# Using iPads for Field Data Collection

Joe Schmit, Technology Resource Manager

Maintenance Division - Washington State Department of Transportation

*2016 Western States Forum - Yreka, California*

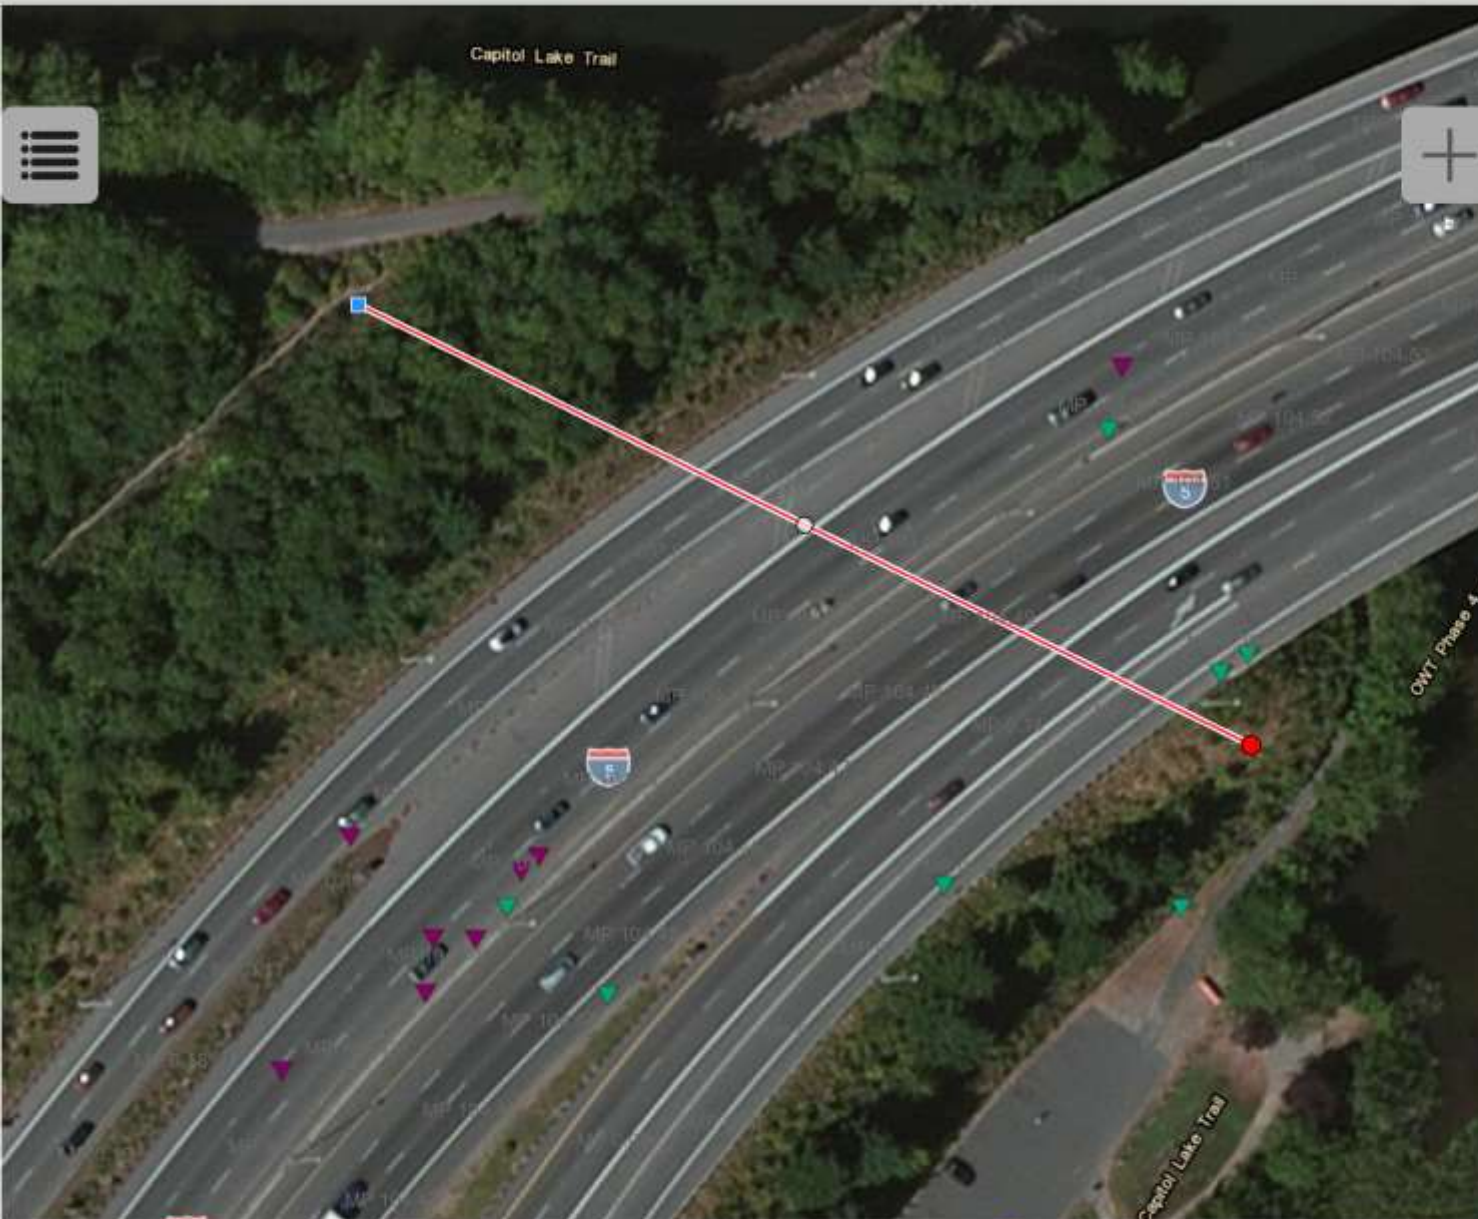
What do you want to  
add to the map?

+ Collect GPS

Length: 435.24 ft

Culvert Added

Culvert has been added to this device's map inventory.

The new feature will be available on the web and other devices after the next sync.

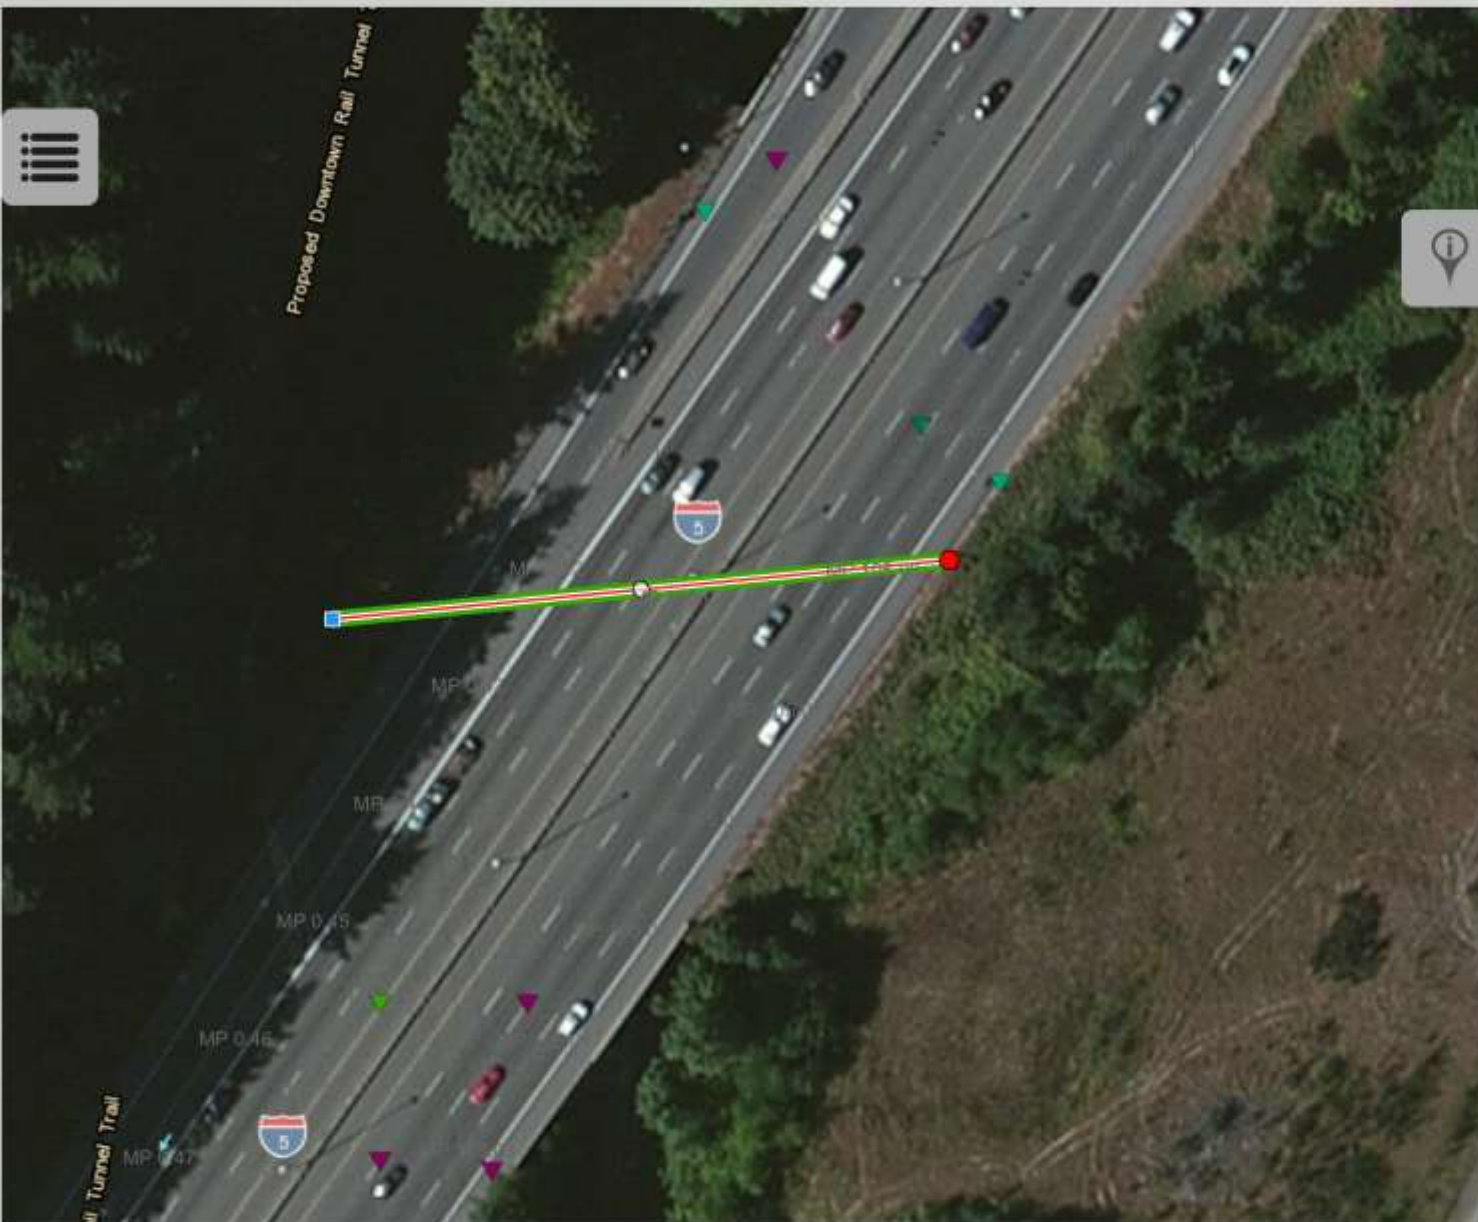
Update the Feature Location

+Collect GPS

Length: 248.01 ft
